# Access Compliance Report Public Rights-of-Way (Curb Ramps)

Main Street: IRVINE\_BLVD Cross Street: DEL\_REY\_DR Location: NE

ADA ID: RPRK211014144414 Ramp Type: Type 4 - Parallel Initial Pass/Fail: Fail Overall Compliance: No Severity Score: 15

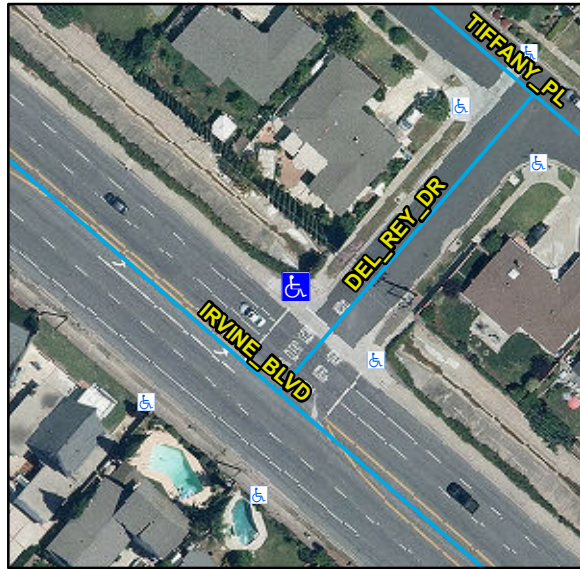
| Compliance | Description | Data | Compliance | Description | Data |
|---|---|---|---|---|---|
| Yes | Ramp Run Slope LT (%) | 7 | No | Ramp Run Slope RT (%) | 9.1 |

Remove & Replace Curb Ramp With Two New Directional Ramps or Equivalent.

R304.3.2, STD 1115
