# Access Compliance Report Public Rights-of-Way (Curb Ramps)

Main Street: DEAN\_ST Cross Street: IRVINE\_BLV Location: W

ADA ID: RPRK211014144957 Ramp Type: Type 4 - Parallel Initial Pass/Fail: Fail Overall Compliance: No Severity Score: 2

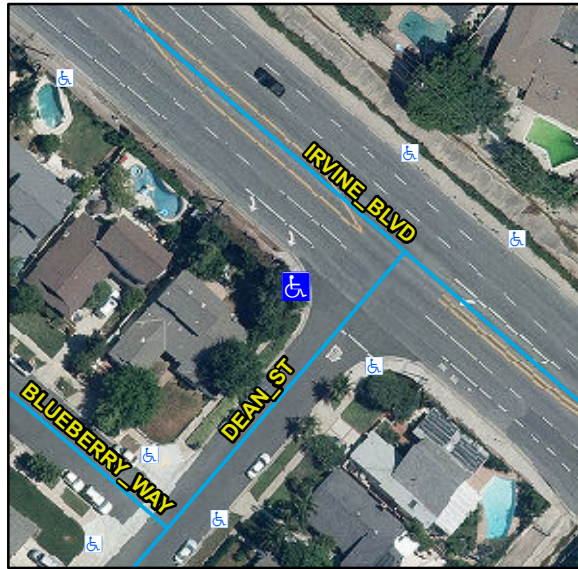
| Compliance | Description | Data | Compliance | Description | Data |
|---|---|---|---|---|---|
| No | Ramp Cross Slope LT (%) | 2.2 | Yes | Ramp Cross Slope RT (%) | 1.3 |

**Remove & Replace Curb Ramp With Two New Directional Ramps or Equivalent.**

**R304.5.3, STD 1115**
