# Access Compliance Report Public Rights-of-Way (Curb Ramps)

Main Street: IRVINE\_BLVD Cross Street: DEAN\_ST Location: SW

ADA ID: RPRK211014145323 Ramp Type: Type 4 - Parallel Initial Pass/Fail: Fail Overall Compliance: No Severity Score: 2

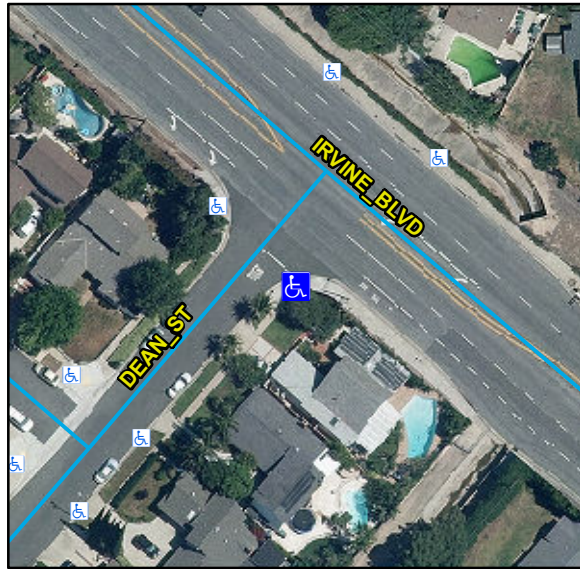
| Compliance | Description | Data | Compliance | Description | Data |
|---|---|---|---|---|---|
| No | Ramp Cross Slope LT (%) | 2.7 | Yes | Ramp Cross Slope RT (%) | 1.4 |

**Remove & Replace Curb Ramp With Two New Directional Ramps or Equivalent.**

**R304.5.3, STD 1115**
