# Access Compliance Report Public Rights-of-Way (Curb Ramps)

Main Street: BRITTANY\_WOODS\_DR Cross Street: IRVINE\_BLV Location: W

ADA ID: RPRK211014145731 Ramp Type: Type 4 - Parallel Initial Pass/Fail: Pass Overall Compliance: No Severity Score: 9

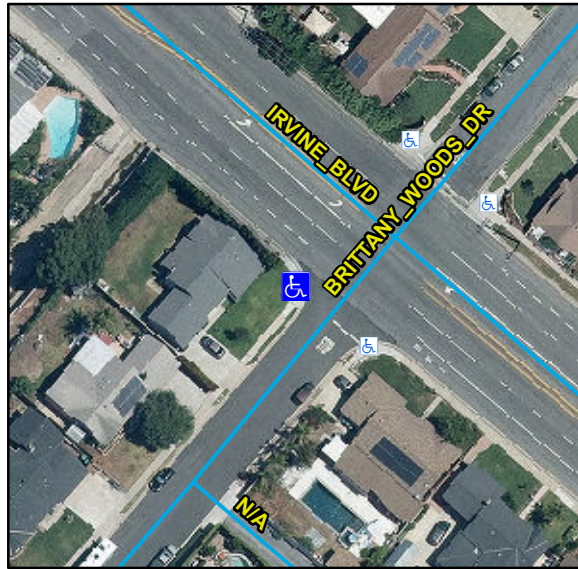
| Compliance | Description | Data | Compliance | Description | Data |
|---|---|---|---|---|---|
| No | Landing Width (in) | 47 | Yes | DWS Length (in) | 36 |
| Yes | Gutter Ponding | No | No | Curb Slope | 8.6 |
| No | Gutter Run Slope (%) | 9.9 | | Road Cross Slope (%) | 4.8 |

Remove & Replace Curb Ramp With Two New Directional Ramps or Equivalent. Remove & Replace Gutter.

R304.2.2, R304.2.1, R304.5.4, STD 1115
