# Access Compliance Report Public Rights-of-Way (Curb Ramps)

Main Street: IRVINE\_BLVD Cross Street: BRITTANY\_WOODS\_DR Location: SW

ADA ID: RPRK211014150036 Ramp Type: Type 4 - Parallel Initial Pass/Fail: Pass Overall Compliance: No Severity Score: 5

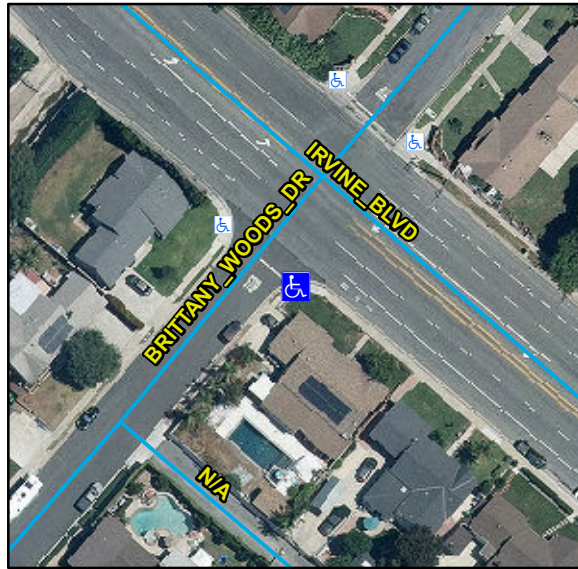
| Compliance | Description | Data | Compliance | Description | Data |
|---|---|---|---|---|---|
| No | Landing Width (in) | N/A | Yes | DWS Length (in) | 36 |
| No | Gutter Run Slope (%) | 5.8 | | Road Cross Slope (%) | 6.8 |

Remove & Replace Landing. Remove & Replace Gutter.
