# Access Compliance Report Public Rights-of-Way (Curb Ramps)

Main Street: CHIRPING\_SPARROW\_WAY Cross Street: IRVINE\_BLV Location: W

ADA ID: RPRK211014150633 Ramp Type: Type 4 - Parallel Initial Pass/Fail: Pass Overall Compliance: No Severity Score: 5

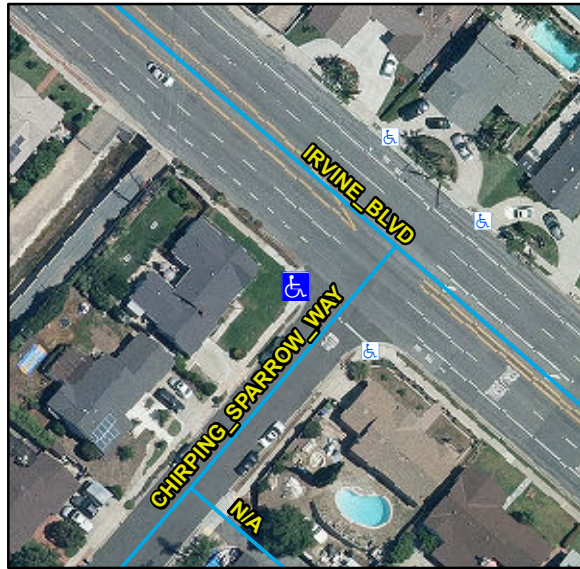
| Compliance | Description | Data | Compliance | Description | Data |
|---|---|---|---|---|---|
| No | Gutter Run Slope (%) | 6.6 | | Road Cross Slope (%) | 5.1 |

Remove & Replace Gutter.

R304.5.4, STD 1115
