Main Street: IRVINE\_BLVD Cross Street: CHIRPING\_SPARROW\_WAY Location: SW

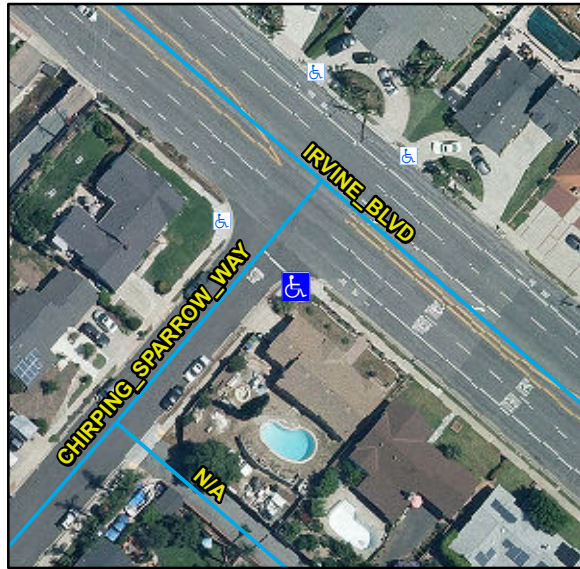
| Compliance | Description | Data | Compliance | Description | Data |
|---|---|---|---|---|---|
| No | Gutter Run Slope (%) | 9.2 | | Road Cross Slope (%) | 2.6 |

Possible Solutions:

Remove & Replace Gutter.

OC Std/PROW:

R304.5.4, STD 1115
