# Access Compliance Report Public Rights-of-Way (Curb Ramps)

Main Street: RAINBOW\_DR Cross Street: DEAN\_ST Location: S

ADA ID: RPRK211014152218 Ramp Type: Type 1 - Perpendicular Diagonal Initial Pass/Fail: Fail Overall Compliance: No Severity Score: 2

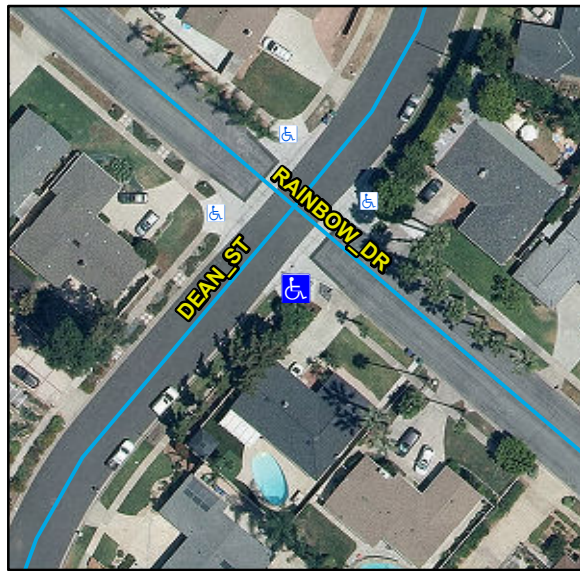
| Compliance | Description | Data | Compliance | Description | Data |
|---|---|---|---|---|---|
| No | Ramp Cross Slope (%) | 3.6 | N/A | Flare Traversable LT | N/A |

Remove & Replace Curb Ramp With Two New Directional Ramps or Equivalent.

R304.5.3, STD 1115
