# Access Compliance Report Public Rights-of-Way (Curb Ramps)

Main Street: DEAN\_ST Cross Street: RAINBOW\_DR Location: NW

ADA ID: RPRK211014152534 Ramp Type: Type 1 - Perpendicular Diagonal Initial Pass/Fail: Fail Overall Compliance: No Severity Score: 15

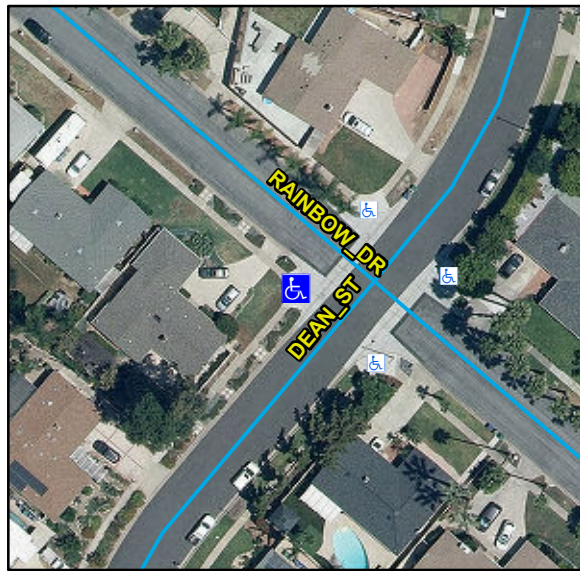
| Compliance | Description | Data | Compliance | Description | Data |
|---|---|---|---|---|---|
| No | Ramp Run Slope (%) | 8.5 | N/A | Flare Slope LT (%) | N/A |

Remove & Replace Curb Ramp With Two New Directional Ramps or Equivalent.

R304.2.2, STD 1115
