# Access Compliance Report Public Rights-of-Way (Curb Ramps)

Main Street: RAINBOW\_DR Cross Street: DEAN\_ST Location: N

ADA ID: RPRK211014152712 Ramp Type: Type 1 - Perpendicular Diagonal Initial Pass/Fail: Fail Overall Compliance: No Severity Score: 16

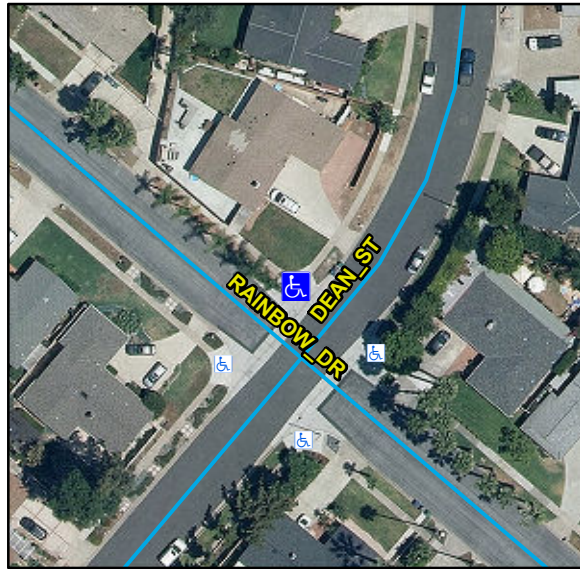
| Compliance | Description | Data | Compliance | Description | Data |
|---|---|---|---|---|---|
| No | Ramp Run Slope (%) | 8.6 | N/A | Flare Slope LT (%) | N/A |

Remove & Replace Curb Ramp With Two New Directional Ramps or Equivalent.

R304.2.2, STD 1115
