# Access Compliance Report Public Rights-of-Way (Curb Ramps)

Main Street: DEAN\_ST Cross Street: RAINBOW\_DR Location: SE

ADA ID: RPRK211014152850 Ramp Type: Type 1 - Perpendicular Diagonal Initial Pass/Fail: Fail Overall Compliance: No Severity Score: 16

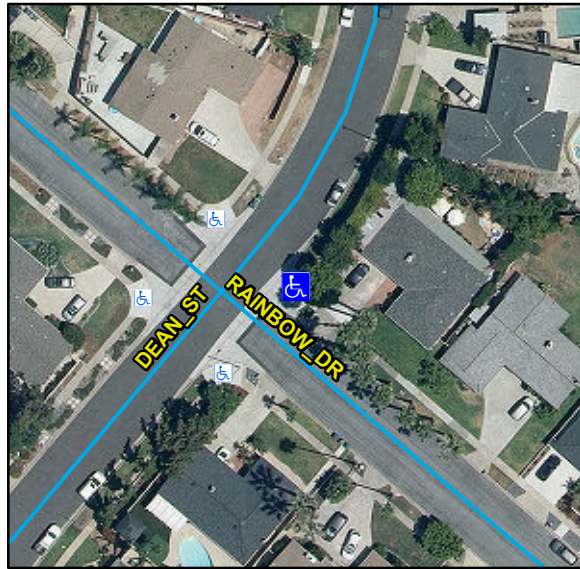
| Compliance | Description | Data | Compliance | Description | Data |
|---|---|---|---|---|---|
| No | Ramp Run Slope (%) | 10.2 | N/A | Flare Slope LT (%) | N/A |
| No | Ramp Cross Slope (%) | 2.5 | N/A | Flare Traversable LT | N/A |

**Remove & Replace Curb Ramp With Two New Directional Ramps or Equivalent.**
