# Access Compliance Report Public Rights-of-Way (Curb Ramps)

Main Street: BRITTANY\_WOODS\_DR Cross Street: RAINBOW\_DR Location: W

ADA ID: RPRK211014153047 Ramp Type: Type 4 - Parallel Initial Pass/Fail: Pass Overall Compliance: No Severity Score: 26

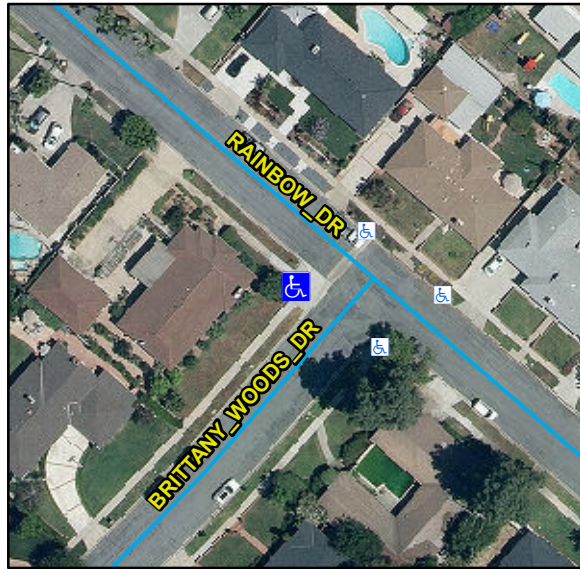
| Compliance | Description | Data | Compliance | Description | Data |
|---|---|---|---|---|---|
| N/A | Landing Present | No | No | DWS Provided | No |
| No | Landing Width (in) | N/A | N/A | DWS Length (in) | N/A |
| No | Landing Run Slope (%) | N/A | N/A | DWS Full Width | N/A |
| No | Landing Cross Slope (%) | N/A | | DWS Offset Type | N/A |
| Yes | Gutter Ponding | No | No | Curb Slope | 8.8 |
| No | Gutter Run Slope (%) | 8.3 | | Road Cross Slope (%) | 1.7 |

Remove & Replace Curb Ramp With Two New Directional Ramps or Equivalent. Remove & Replace Gutter.
