# Access Compliance Report Public Rights-of-Way (Curb Ramps)

Main Street: RAINBOW\_DR Cross Street: BRITTANY\_WOODS\_DR Location: S

ADA ID: RPRK211014153453 Ramp Type: Type 4 - Parallel Initial Pass/Fail: Fail Overall Compliance: No Severity Score: 2

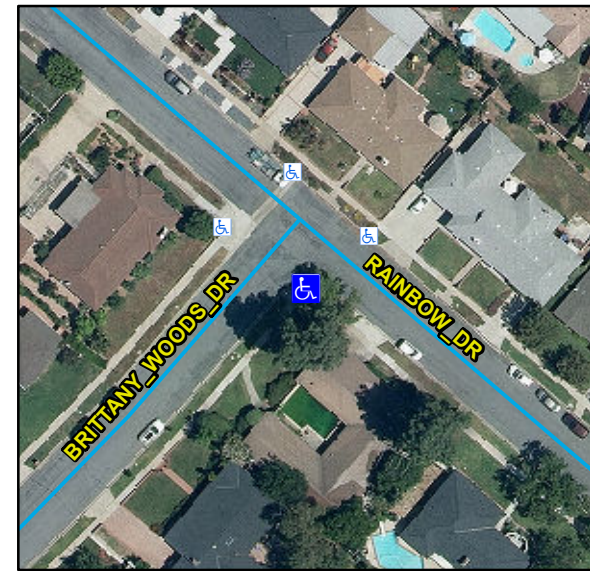
| Compliance | Description | Data | Compliance | Description | Data |
|---|---|---|---|---|---|
| Yes | Ramp Cross Slope LT (%) | 0.5 | No | Ramp Cross Slope RT (%) | 4.5 |

**Remove & Replace Curb Ramp With Two New Directional Ramps or Equivalent.**

**R304.5.3, STD 1115**

Total Cost: \$ 4000
