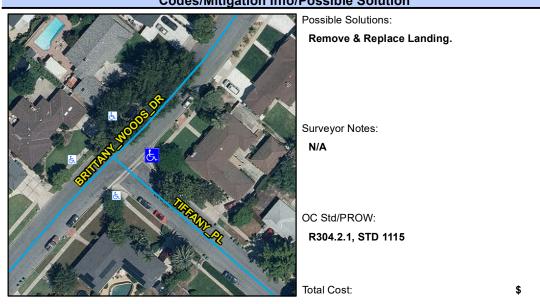
Main Street: BRITTANY WOODS DR **Cross Street: TIFFANY PL** Location:

Field Measurements/Component Compliance								
	Compliance Description		Data	Compliance Description		Data		
	N/A	Ramp Length (in)	116	N/A	Flare Type LT			
	Yes	Ramp Width (in)	48			Sloped		
	Yes	Ramp Run Slope (%)	5.9	Yes	Flare Slope LT (%)	3.9		
	Yes	Ramp Cross Slope (%)	0.1	N/A	Flare Traversable LT	Yes		
	N/A	Landing Present	Yes	N/A	Flare Type RT			
	N/A	Landing Length (in)	48			Sloped		
	Yes	Landing Width (in)	48	Yes	Flare Slope RT (%)	3.5		
	Yes	Landing Run Slope (%)	1.7	N/A	Flare Traversable RT	Yes		
	Yes	Landing Cross Slope (%)	0.2	Yes	DWS Provided	Yes		
	N/A	Landing Movement Obstructed?	Yes	Yes	DWS Contrast	Yes		
		Landing Movement Type	Curb	Yes	DWS Length (in)	36		
	N/A	Landing Shared	No	Yes	DWS Full Width	Yes		
	N/A	Clear Space	Yes	Yes	DWS Offset Left (in)	0		
	N/A	Clear Space To Crosswalk (in)	48	Yes	DWS Offset Right (in)	N/A		
531	N/A	Marked Crosswalk 1	No	N/A	Marked Crosswalk 2	No		
		Crossing 1 Direction	NW		Crossing 2 Direction	SW
