# Access Compliance Report Public Rights-of-Way (Curb Ramps)

Main Street: TIFFANY\_PL Cross Street: BRITTANY\_WOODS\_DR Location: SW

ADA ID: RPRK211014154355 Ramp Type: Type 4 - Parallel Initial Pass/Fail: Fail Overall Compliance: No Severity Score: 16

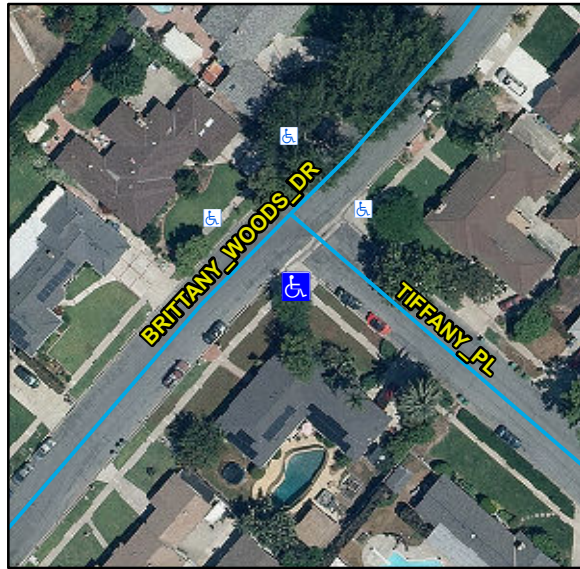
| Compliance | Description | Data | Compliance | Description | Data |
|---|---|---|---|---|---|
| No | Ramp Run Slope LT (%) | 8.9 | Yes | Ramp Run Slope RT (%) | 6.9 |
| No | Ramp Cross Slope LT (%) | 3.4 | No | Ramp Cross Slope RT (%) | 4.9 |

**Remove & Replace Curb Ramp With Two New Directional Ramps or Equivalent.**

**R304.3.2, R304.5.3, STD 1115**
