# Access Compliance Report

## Public Rights-of-Way

### (Curb Ramps)

Main Street: BRITTANY\_WOODS\_DR Cross Street: IRVINE\_BLV Location: SE

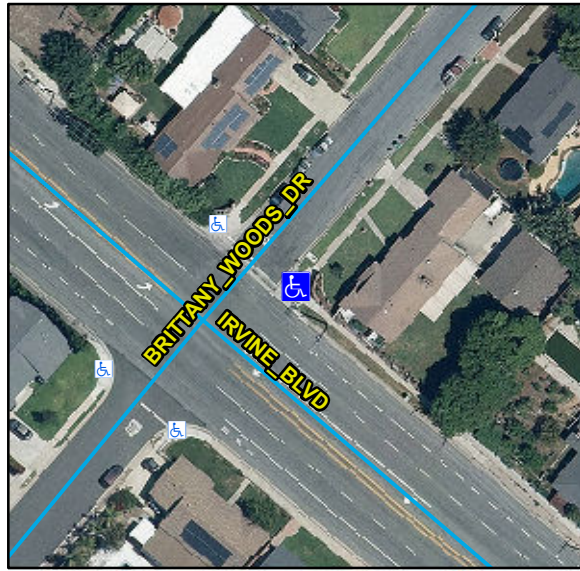
ADA ID: RPRK211014155227 Ramp Type: Type 4 - Parallel Initial Pass/Fail: Pass Overall Compliance: No Severity Score: 0

| Compliance | Description | Data | Compliance | Description | Data |
|---|---|---|---|---|---|
| Yes | Gutter Ponding | No | No | Curb Slope | 8.4 |
| Yes | Gutter Cross Slope (%) | 0.4 | No | Perpendicular Joint Present | No |

**Remove & Replace Curb Ramp With Two New Directional Ramps or Equivalent.**

**R304.2.2, R204.3, STD 1115**

Total Cost: \$ 4000
