# Access Compliance Report Public Rights-of-Way (Curb Ramps)

| Main Street: IRVINE_BLVD | | Cross Street: BRITTANY_WOODS_DR | | Location: | NE |
| ADA ID: RPRK211014155528 | Ramp Type: Type 4 - Parallel | Initial Pass/Fail: Pass | Overall Compliance: No | Severity Score: | 0 |

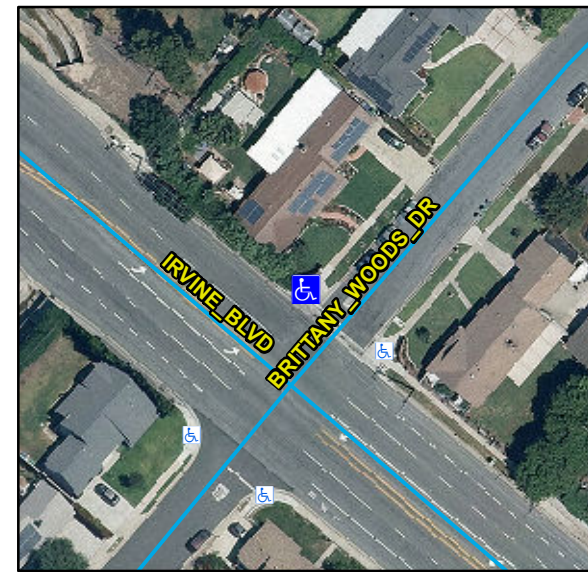
| Compliance | Description | Data | Compliance | Description | Data |
|---|---|---|---|---|---|
| No | Landing Cross Slope (%) | 2.3 | | DWS Offset Type | Single |
| Yes | Gutter Ponding | No | No | Curb Slope | 8.4 |
| No | Gutter Cross Slope (%) | 2.3 | No | Perpendicular Joint Present | No |

**Remove & Replace Curb Ramp With Two New Directional Ramps or Equivalent. Remove & Replace Gutter.**

**R304.2.2, R204.3, R304.5.3, STD 1115**
