# Access Compliance Report Public Rights-of-Way (Curb Ramps)

Main Street: CAY\_ST Cross Street: LA\_COLINA\_DR Location: NW

ADA ID: RPRK211014171605 Ramp Type: Type 4 - Parallel Initial Pass/Fail: Fail Overall Compliance: No Severity Score: 15

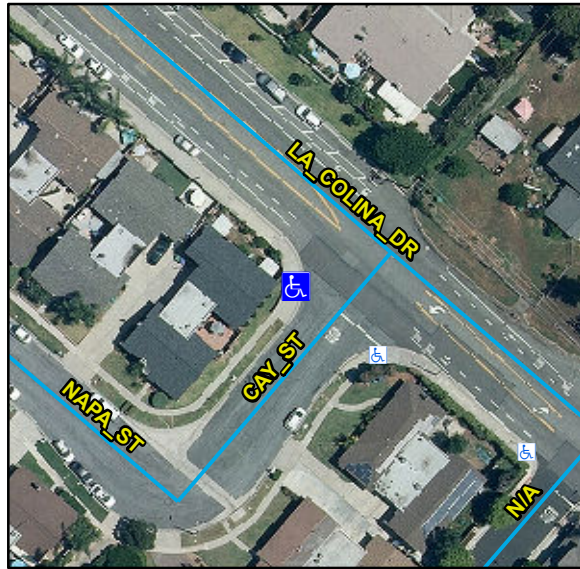
| Compliance | Description | Data | Compliance | Description | Data |
|---|---|---|---|---|---|
| Yes | Ramp Run Slope LT (%) | 1.5 | Yes | Ramp Run Slope RT (%) | 8.1 |
| No | Ramp Cross Slope LT (%) | 3.6 | No | Ramp Cross Slope RT (%) | 5.5 |

Remove & Replace Curb Ramp With Two New Directional Ramps or Equivalent.

R204.3, R304.5.3, STD 1115

Total Cost: \$ 4000
