# Access Compliance Report Public Rights-of-Way (Curb Ramps)

Main Street: LA\_COLINA\_DR Cross Street: CAY\_ST Location: S

ADA ID: RPRK211014171812 Ramp Type: Type 4 - Parallel Initial Pass/Fail: Fail Overall Compliance: No Severity Score: 2

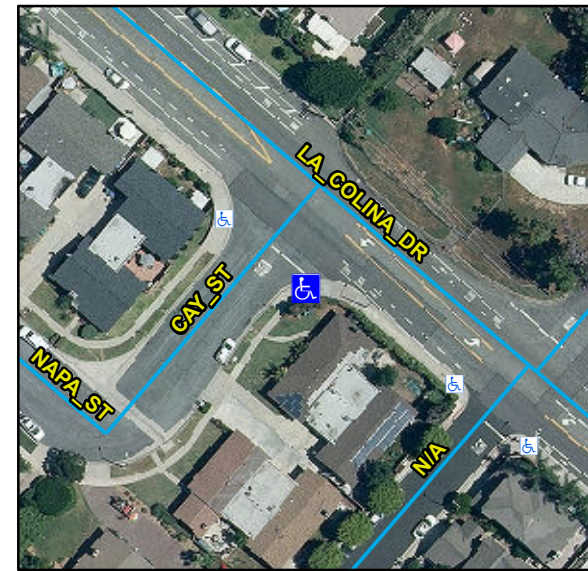
| Compliance | Description | Data | Compliance | Description | Data |
|---|---|---|---|---|---|
| No | Ramp Cross Slope LT (%) | 4 | No | Ramp Cross Slope RT (%) | 3.5 |

**Remove & Replace Curb Ramp With Two New Directional Ramps or Equivalent.**

**R204.3, R304.5.3, STD 1115**
