# Access Compliance Report Public Rights-of-Way (Curb Ramps)

| Main Street: WINDSOR_LN | | Cross Street: DEL_REY_DR | | Location: | NE |
| ADA ID: RPRK211014172649 | Ramp Type: Type 4 - Parallel | Initial Pass/Fail: Fail | Overall Compliance: No | Severity Score: | 2 |

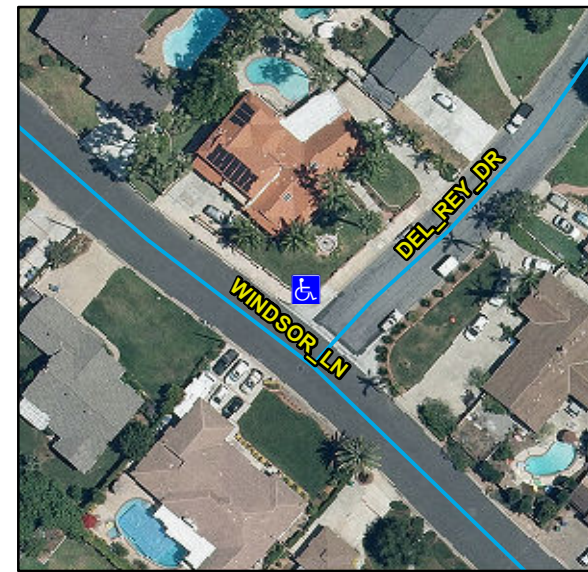
**R304.5.3, R302.3, R402.2, STD 1115**

| Compliance | Description | Data | Compliance | Description | Data |
|---|---|---|---|---|---|
| No | Obstructions Present? | Yes | N/A | Utilities Present? | No |
| | Obstruction Types | Fire Hydrant | | Utility Types | |

| Compliance | Description | Data | Compliance | Description | Data |
|---|---|---|---|---|---|
| No | Ramp Cross Slope LT (%) | 2.9 | No | Ramp Cross Slope RT (%) | 2.2 |

**Remove & Replace Curb Ramp With Two New Directional Ramps or Equivalent.**

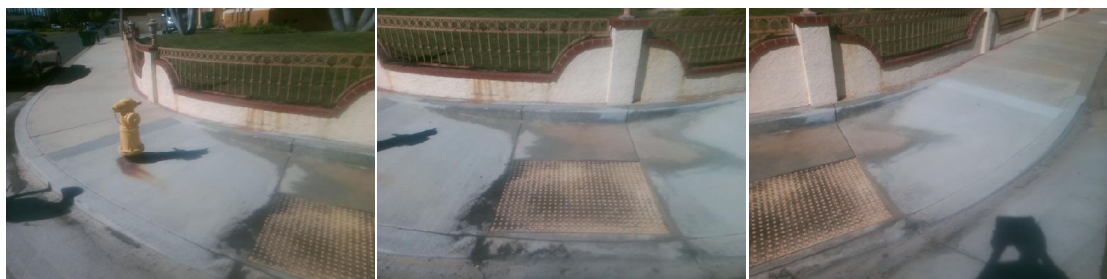
| Compliance | Description | Data | Compliance | Description | Data |
|---|---|---|---|---|---|
| N/A | Ramp Length LT (in) | 102 | N/A | Ramp Length RT (in) | 102 |
| Yes | Ramp Width LT (in) | 71 | Yes | Ramp Width RT (in) | 70 |
| Yes | Ramp Run Slope LT (%) | 4.7 | Yes | Ramp Run Slope RT (%) | 5.7 |
