# Access Compliance Report Public Rights-of-Way (Curb Ramps)

Main Street: WINDSOR\_LN Cross Street: RED\_HILL\_AVE Location: SE

ADA ID: RPRK211014173116 Ramp Type: Type 7 - Directional 2 Initial Pass/Fail: Fail Overall Compliance: No Severity Score: 16

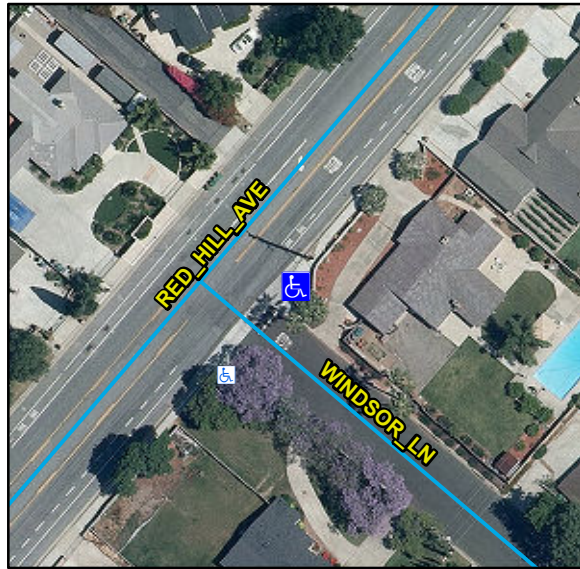
| Compliance | Description | Data | Compliance | Description | Data |
|---|---|---|---|---|---|
| No | Ramp Cross Slope (%) | 2.1 | N/A | Flare Traversable LT | N/A |

Remove & Replace Entire Ramp.

R304.5.3, STD 1115
