# Access Compliance Report Public Rights-of-Way (Curb Ramps)

Main Street: WINDSOR\_LN Cross Street: RED\_HILL\_AVE Location: S

ADA ID: RPRK211014173251 Ramp Type: Type 6 - Directional 1 Initial Pass/Fail: Pass Overall Compliance: No Severity Score: 6

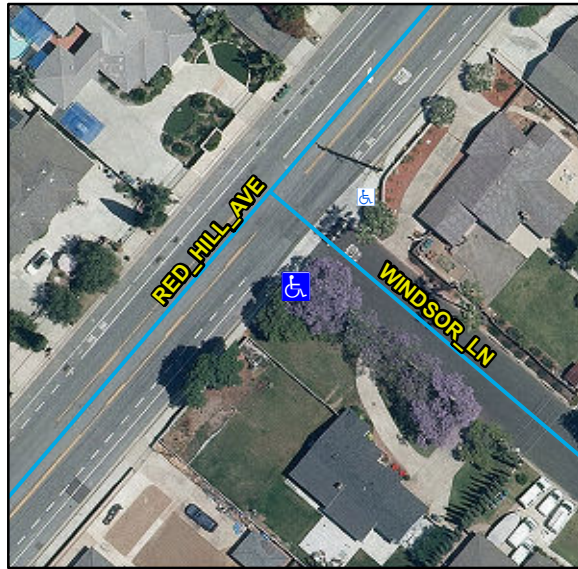
| Compliance | Description | Data | Compliance | Description | Data |
|---|---|---|---|---|---|
| No | Landing Length (in) | 40 | Yes | DWS Length (in) | 70 |
| No | Landing Cross Slope (%) | 2.8 | Yes | DWS Left Offset (in) | 0 |
| Yes | Gutter Ponding | No | No | Curb Slope | 10.8 |
| No | Gutter Cross Slope (%) | 3 | | Parallel Ramp Side | Left |

Remove & Replace Entire Ramp. Remove & Replace Gutter.

R304.2.2, R304.2.1, R304.5.3, STD 1115
