# Access Compliance Report Public Rights-of-Way (Curb Ramps)

Main Street: SIERRA\_ALTA\_DR Cross Street: RED\_HILL\_AVE Location: SE

ADA ID: RPRK211014173615 Ramp Type: Type 6 - Directional 1 Initial Pass/Fail: Pass Overall Compliance: No Severity Score: 10

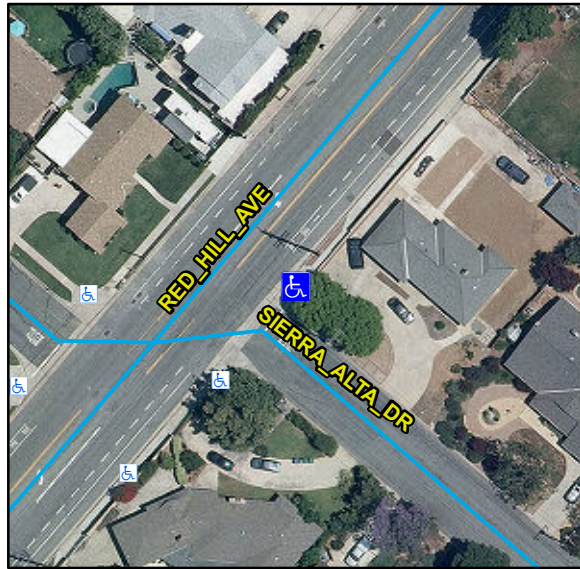
| Compliance | Description | Data | Compliance | Description | Data |
|---|---|---|---|---|---|
| No | Grade Break Cross Slope (%) | 2.3 | N/A | Flare Slope RT (%) | N/A |
| | Addl Para Ramp Right? | No | No | DWS Provided | No |
| No | Gutter Cross Slope (%) | 3 | | Parallel Ramp Side | Right |

Remove & Replace Entire Ramp. Remove & Replace Gutter.

R304.5.3, R305, STD 1115
