# Access Compliance Report Public Rights-of-Way (Curb Ramps)

Main Street: SIERRA\_ALTA\_DR Cross Street: RED\_HILL\_AVE Location: SW

ADA ID: RPRK211014174058 Ramp Type: Type 7 - Directional 2 Initial Pass/Fail: Fail Overall Compliance: No Severity Score: 2

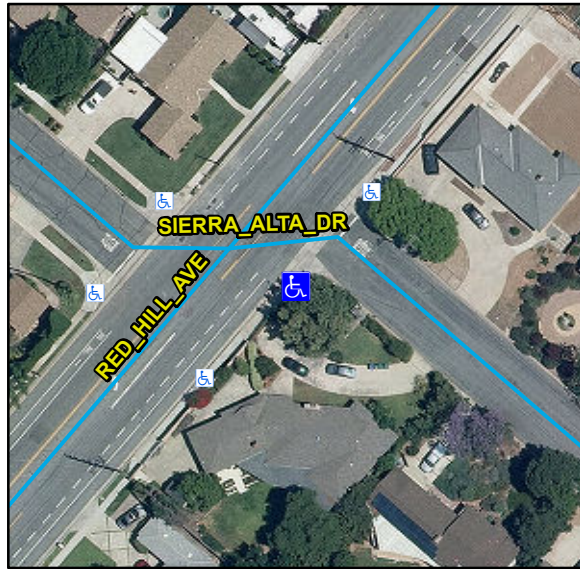
| Compliance | Description | Data | Compliance | Description | Data |
|---|---|---|---|---|---|
| No | Ramp Cross Slope (%) | 2.3 | N/A | Flare Traversable LT | N/A |
| No | Gutter Lip Height (in) | 1 | | Road Run Slope (%) | N/A |

Remove & Replace Entire Ramp. Grind Gutter Lip.

R304.5.3, R302.7.2, STD 1115
