# Access Compliance Report Public Rights-of-Way (Curb Ramps)

| Main Street: RED_HILL_AVE | | Cross Street: BULLARD_LN | | Location: | NW |
| ADA ID: RPRK211014175306 | Ramp Type:Type 1 - Perpendicular Diagonal Initial Pass/Fail: Fail | | Overall Compliance: No | Severity Score: | 16 |

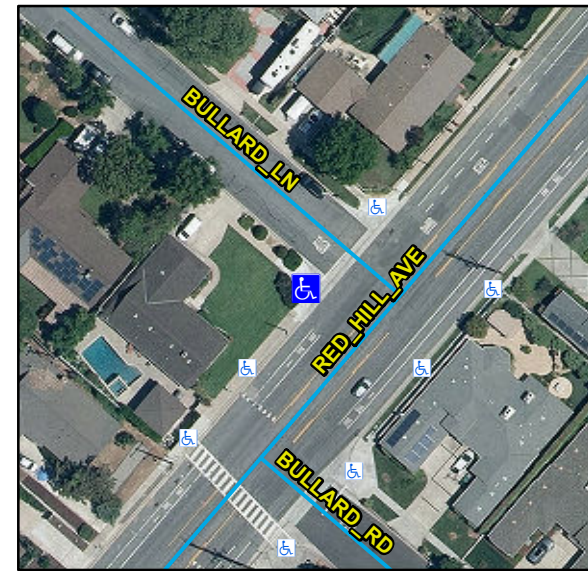
| Compliance | Description | Data | Compliance | Description | Data |
|---|---|---|---|---|---|
| No | Ramp Run Slope (%) | 8.9 | N/A | Flare Slope LT (%) | N/A |
| No | Ramp Cross Slope (%) | 2.2 | N/A | Flare Traversable LT | N/A |

**Remove & Replace Curb Ramp With Two New Directional Ramps or Equivalent.**

**R304.2.2, R304.5.3, STD 1115**
