# Access Compliance Report Public Rights-of-Way (Curb Ramps)

| Main Street: RED_HILL_AVE | | Cross Street: BULLARD_RD | | Location: | NW |
| ADA ID: RPRK211014175456 | Ramp Type: Type 4 - Parallel | Initial Pass/Fail: Fail | Overall Compliance: No | Severity Score: | 2 |

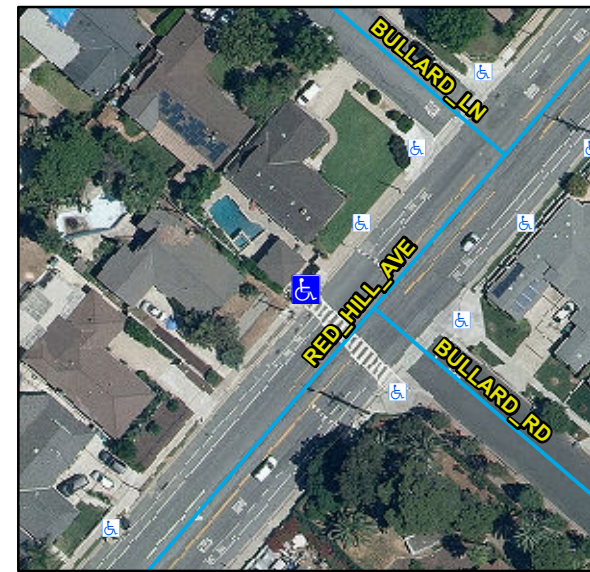
| Compliance | Description | Data | Compliance | Description | Data |
|---|---|---|---|---|---|
| No | Ramp Cross Slope LT (%) | 2.8 | No | Ramp Cross Slope RT (%) | 2.4 |

Possible Solutions:

Remove & Replace Entire Ramp.

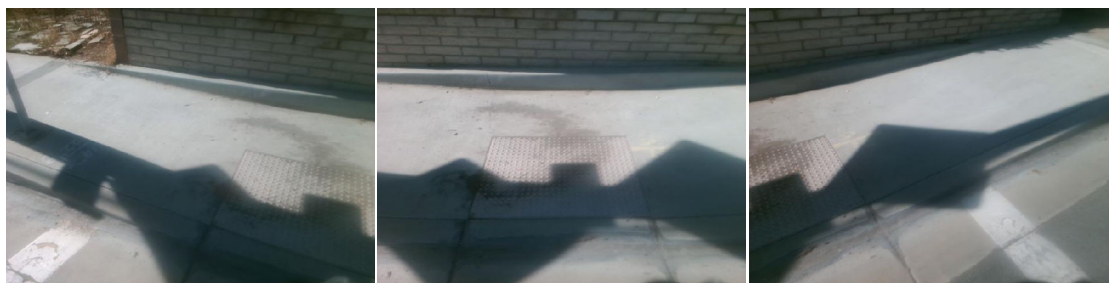
| Compliance | Description | Data | Compliance | Description | Data |
|---|---|---|---|---|---|
| N/A | Ramp Length LT (in) | 111 | N/A | Ramp Length RT (in) | 168 |
| Yes | Ramp Width LT (in) | 70 | Yes | Ramp Width RT (in) | 70 |
| Yes | Ramp Run Slope LT (%) | 5.7 | Yes | Ramp Run Slope RT (%) | 7.6 |
