# Access Compliance Report Public Rights-of-Way (Curb Ramps)

Main Street: RED\_HILL\_AVE Cross Street: BULLARD\_RD Location: E

ADA ID: RPRK211014175946 Ramp Type: Type 1 - Perpendicular Diagonal Initial Pass/Fail: Pass Overall Compliance: No Severity Score: 4

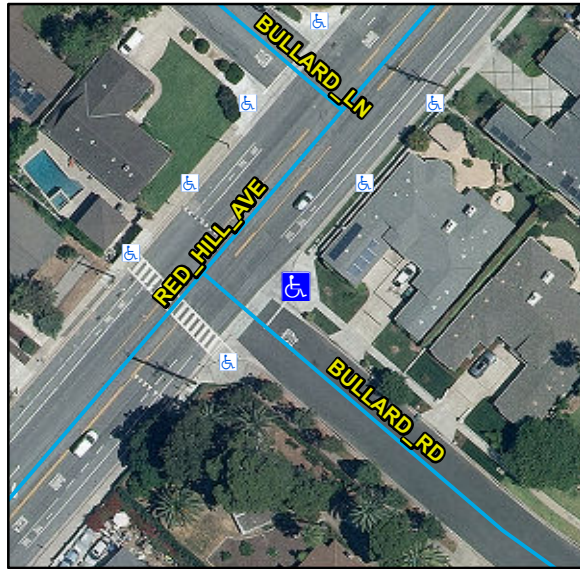
| Compliance | Description | Data | Compliance | Description | Data |
|---|---|---|---|---|---|
| No | Landing Run Slope (%) | 2.5 | N/A | Flare Traversable RT | Yes |
| Yes | Gutter Ponding | No | No | Curb Slope | 7.7 |

Remove & Replace Curb Ramp With Two New Directional Ramps or Equivalent.
