# Access Compliance Report Public Rights-of-Way (Curb Ramps)

| Main Street: BULLARD_RD | | Cross Street: RED_HILL_AVE | | Location: | S |
| ADA ID: RPRK211014180238 | Ramp Type: Type 4 - Parallel | Initial Pass/Fail: Fail | Overall Compliance: No | Severity Score: | 15 |

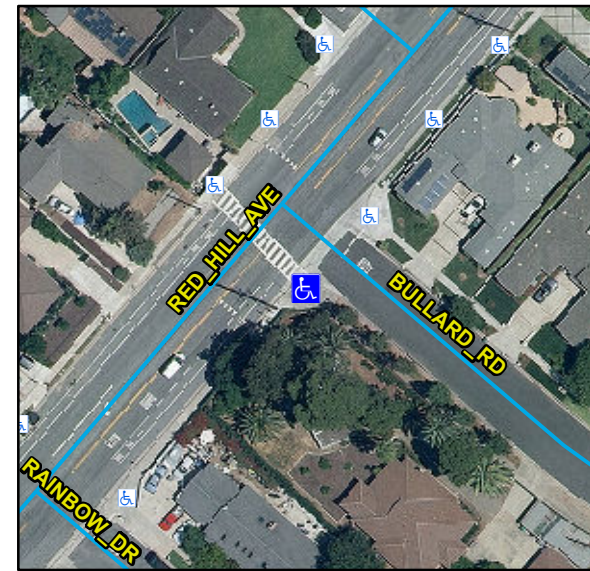
| Compliance | Description | Data | Compliance | Description | Data |
|---|---|---|---|---|---|
| No | Ramp Cross Slope LT (%) | 5.5 | No | Ramp Cross Slope RT (%) | 5.8 |

**Remove & Replace Curb Ramp With Two New Directional Ramps or Equivalent.**

**R204.3, R304.5.3, STD 1115**

Total Cost: \$ 4000

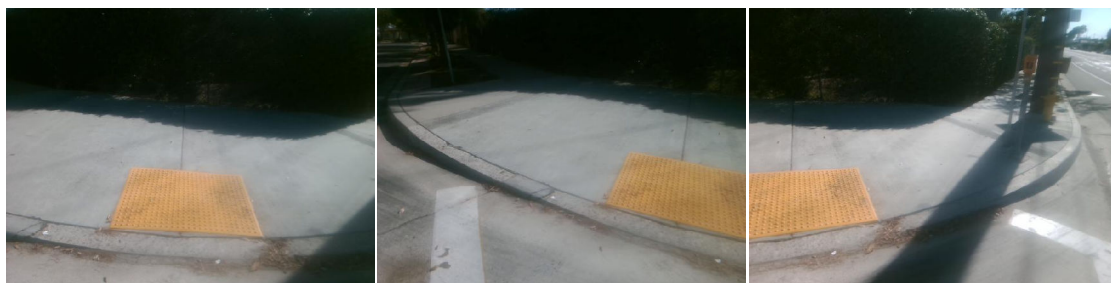
| Compliance | Description | Data | Compliance | Description | Data |
|---|---|---|---|---|---|
| N/A | Ramp Length LT (in) | 85 | N/A | Ramp Length RT (in) | 89 |
| Yes | Ramp Width LT (in) | 155 | Yes | Ramp Width RT (in) | 150 |
| Yes | Ramp Run Slope LT (%) | 8.2 | Yes | Ramp Run Slope RT (%) | 4.2 |
