# Access Compliance Report Public Rights-of-Way (Curb Ramps)

Main Street: MESA\_DR Cross Street: IRVINE\_AVE Location: NE

ADA ID: RPRK211015140141 Ramp Type: Type 1 - Perpendicular Diagonal Initial Pass/Fail: Pass Overall Compliance: No Severity Score: 10

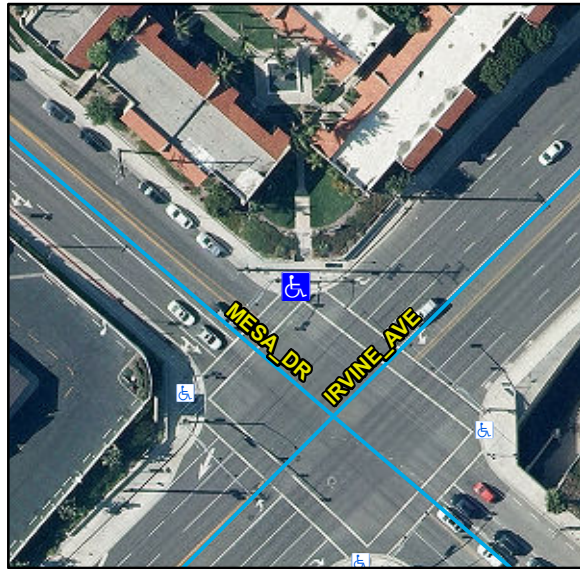
| Compliance | Description | Data | Compliance | Description | Data |
|---|---|---|---|---|---|
| No | Landing Run Slope (%) | 4 | N/A | Flare Traversable RT | Yes |
| Yes | Landing Cross Slope (%) | 1.5 | No | DWS Provided | No |
| | Landing Movement Type | Stairs | N/A | DWS Length (in) | N/A |
| Yes | Gutter Ponding | No | No | Curb Slope | 12.1 |

Remove & Replace Curb Ramp With Two New Directional Ramps or Equivalent.

R304.2.2, R304.2.1, R304.2.2-Perp, R304.3.2-Para, R305, STD 1115
