# Access Compliance Report Public Rights-of-Way (Curb Ramps)

Main Street: IRVINE\_AVE Cross Street: MESA\_DR Location: NW

ADA ID: RPRK211015140839 Ramp Type: Type 1 - Perpendicular Diagonal Initial Pass/Fail: Pass Overall Compliance: No Severity Score: 4

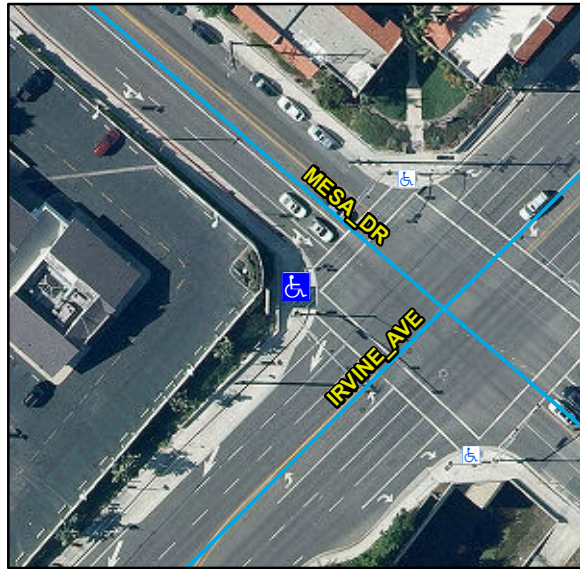
| Compliance | Description | Data | Compliance | Description | Data |
|---|---|---|---|---|---|
| No | Landing Width (in) | 47 | Yes | Flare Slope RT (%) | 7.9 |
| No | Landing Cross Slope (%) | 2.9 | Yes | DWS Provided | Yes |
| No | Gutter Cross Slope (%) | 4.2 | | | |

Remove & Replace Curb Ramp With Two New Directional Ramps or Equivalent. Remove & Replace Gutter.

R304.2.2, R304.2.1, R304.5.3, STD 1115
