# Access Compliance Report Public Rights-of-Way (Curb Ramps)

Main Street: IRVINE\_AVE Cross Street: MESA\_DR Location: SE

ADA ID: RPRK211015142215 Ramp Type: Type 1 - Perpendicular Diagonal Initial Pass/Fail: Fail Overall Compliance: No Severity Score: 19

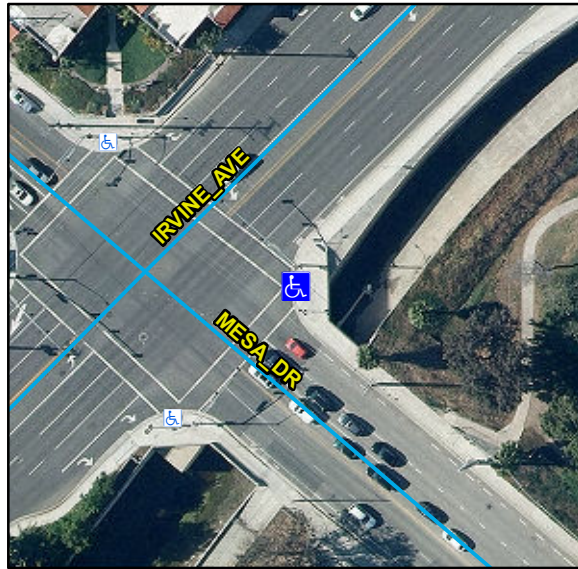
| Compliance | Description | Data | Compliance | Description | Data |
|---|---|---|---|---|---|
| No | Ramp Width (in) | 47 | | | N/A |
| No | Ramp Run Slope (%) | 11 | N/A | Flare Slope LT (%) | N/A |

Remove & Replace Curb Ramp With Two New Directional Ramps or Equivalent.

R304.2.2, R304.5.1, STD 1115
