# Access Compliance Report Public Rights-of-Way (Curb Ramps)

Main Street: SANTA\_ANA\_AVE Cross Street: UNIVERSITY\_DR Location: SE

ADA ID: RPRK211018105245 Ramp Type: Type 1 - Perpendicular Diagonal Initial Pass/Fail: Pass Overall Compliance: No Severity Score: 6

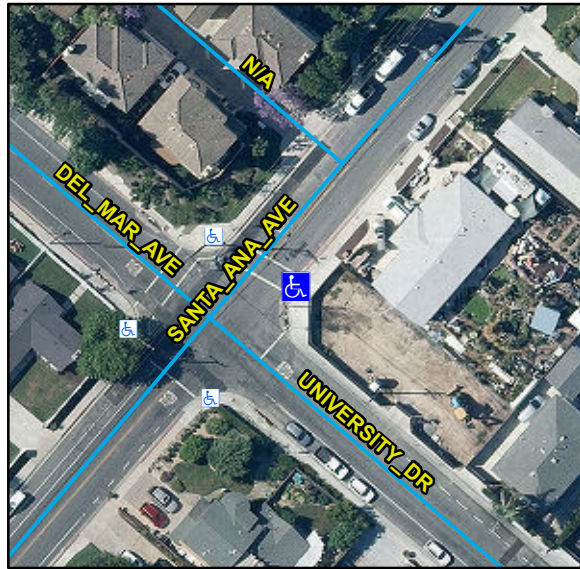
| Compliance | Description | Data | Compliance | Description | Data |
|---|---|---|---|---|---|
| No | Landing Run Slope (%) | 2.5 | N/A | Flare Traversable RT | Yes |
| No | Gutter Run Slope (%) | 6.8 | | Road Cross Slope (%) | 3.6 |

Remove & Replace Curb Ramp With Two New Directional Ramps or Equivalent. Remove & Replace Gutter.
