# Access Compliance Report Public Rights-of-Way (Curb Ramps)

Main Street: N/A Cross Street: UNIVERSITY\_DR Location: NW

ADA ID: RPRK211018110136 Ramp Type: Type 6 - Directional 1 Initial Pass/Fail: Pass Overall Compliance: No Severity Score: 10

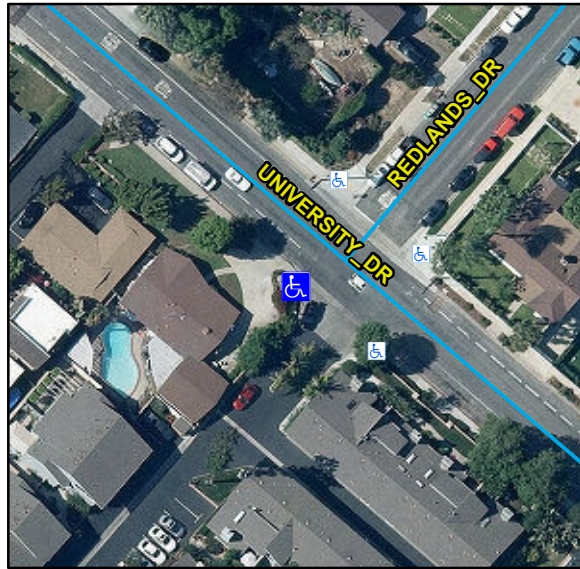
| Compliance | Description | Data | Compliance | Description | Data |
|---|---|---|---|---|---|
| N/A | Landing Present | No | Yes | DWS Contrast | Yes |
| No | Landing Length (in) | N/A | Yes | DWS Length (in) | 116 |
| No | Landing Width (in) | N/A | Yes | DWS Full Width | Yes |
| No | Landing Run Slope (%) | N/A | | DWS Offset Type | Single |
| No | Landing Cross Slope (%) | N/A | Yes | DWS Left Offset (in) | 0 |

Possible Solutions:

Install Landing.

OC Std/PROW:

R304.2.1, R304.2.2-Perp, R304.3.2-Para, R304.5.3, STD 1115
