# Access Compliance Report Public Rights-of-Way (Curb Ramps)

| Main Street: UNIVERSITY_DR | | Cross Street: N/A | | Location: | SW |
| ADA ID: RPRK211018110608 | Ramp Type: Type 4 - Parallel | Initial Pass/Fail: Fail | Overall Compliance: No | Severity Score: | 30 |

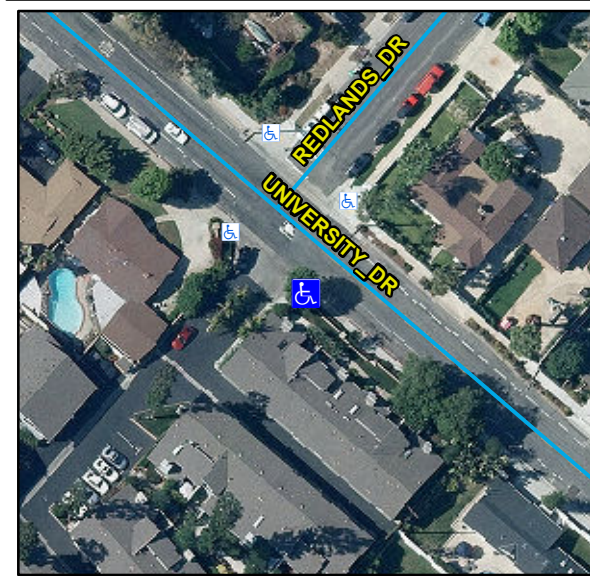
| Compliance | Description | Data | Compliance | Description | Data |
|---|---|---|---|---|---|
| No | Ramp Cross Slope LT (%) | 7.2 | Yes | Ramp Cross Slope RT (%) | 0.2 |

**Remove & Replace Curb Ramp With Two New Directional Ramps or Equivalent.**

**R304.5.3, STD 1115**
