# Access Compliance Report Public Rights-of-Way (Curb Ramps)

Main Street: UNIVERSITY\_DR Cross Street: REDLANDS\_DR Location: N

ADA ID: RPRK211018110838 Ramp Type: Type 4 - Parallel Initial Pass/Fail: Fail Overall Compliance: No Severity Score: 2

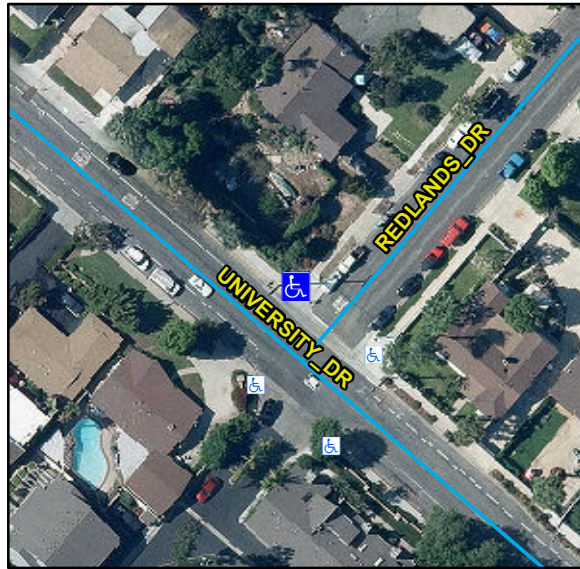
| Compliance | Description | Data | Compliance | Description | Data |
|---|---|---|---|---|---|
| No | Ramp Cross Slope LT (%) | 3.9 | No | Ramp Cross Slope RT (%) | 3.9 |

**Remove & Replace Curb Ramp With Two New Directional Ramps or Equivalent.**

**R304.5.3, STD 1115**
