Access Compliance Report Public Rights-of-Way (Curb Ramps)

Main Street: REDLANDS_DR **Cross Street:** UNIVERSITY_DR **Location:** SE

ADA ID: RPRK211018111130 **Ramp Type:** Type 4 - Parallel **Initial Pass/Fail:** Fail **Overall Compliance:** No **Severity Score:** 2

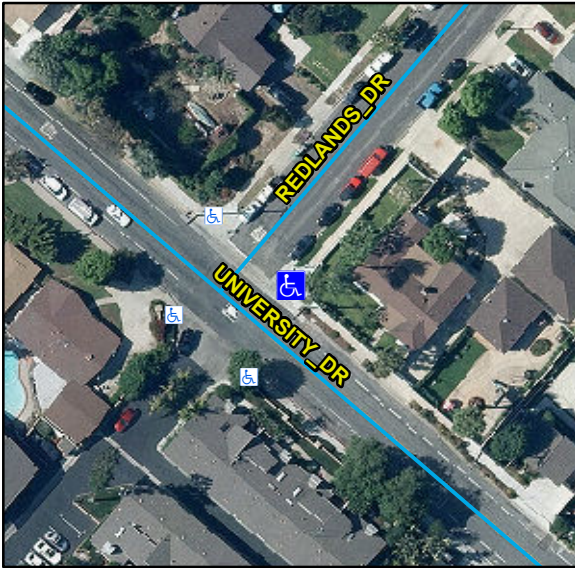
Compliance	Description	Data	Compliance	Description	Data
N/A	Ramp Length LT (in)	98	N/A	Ramp Length RT (in)	98
Yes	Ramp Width LT (in)	103	Yes	Ramp Width RT (in)	102
Yes	Ramp Run Slope LT (%)	4.8	Yes	Ramp Run Slope RT (%)	3.3
Yes	Ramp Cross Slope LT (%)	1.8	No	Ramp Cross Slope RT (%)	2.8
N/A	Landing Present	N/A	N/A	DWS Provided	N/A
N/A	Landing Length (in)	N/A	N/A	DWS Contrast	N/A
N/A	Landing Width (in)	N/A	N/A	DWS Length (in)	N/A
N/A	Landing Run Slope (%)	N/A	N/A	DWS Full Width	N/A
N/A	Landing Cross Slope (%)	N/A		DWS Offset Type	N/A
N/A	Landing Movement Obstructed?	N/A	N/A	DWS Offset Left (in)	N/A
	Landing Movement Type	N/A	N/A	DWS Offset Right (in)	N/A
N/A	Landing Shared	N/A			
N/A	Clear Space	Yes			
N/A	Clear Space To Crosswalk (in)	N/A			
N/A	Marked Crosswalk 1	No	N/A	Marked Crosswalk 2	No
	Crossing 1 Direction	NW		Crossing 2 Direction	SW
	Marked Crosswalk 1 Width (in)	N/A		Marked Crosswalk 2 Width (in)	N/A

N/A	Ramp Inside Crosswalk 1	N/A	N/A	Ramp Inside Crosswalk 2	N/A
	Crossing 1 Slope (%)	4.3		Crossing 2 Slope (%)	3.4
	Crossing 1 Cross Slope (%)	4.3		Crossing 2 Cross Slope (%)	0.8
N/A	Gutter Ponding	N/A	Yes	Curb Slope	2.8
Yes	Gutter Lip Height (in)	0		Road Run Slope (%)	0.7
N/A	Gutter Run Slope (%)	N/A		Road Cross Slope (%)	1.9
N/A	Gutter Cross Slope (%)	N/A	Yes	Perpendicular Joint Present	Yes
Yes	Overall Surface Condition	Acceptable			
	Cross Gutter Present?	Yes		Spandrel Present?	Yes
	Replace Cross Gutter?	No		Replace Spandrel?	No

Possible Solutions:
Remove & Replace Curb Ramp With Two New Directional Ramps or Equivalent.

OC Std/PROW:
R304.5.3, STD 1115

Total Cost: \$ 4000
