# Access Compliance Report Public Rights-of-Way (Curb Ramps)

Main Street: WILLO\_LN Cross Street: UNIVERSITY\_DR Location: W

ADA ID: RPRK211018112052 Ramp Type: Type 6 - Directional 1 Initial Pass/Fail: Fail Overall Compliance: No Severity Score: 2

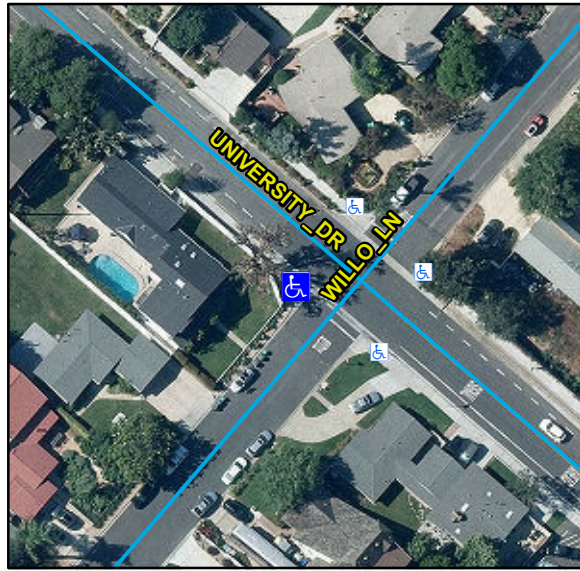
| Compliance | Description | Data | Compliance | Description | Data |
|---|---|---|---|---|---|
| No | Ramp Cross Slope (%) | 2.1 | N/A | Flare Traversable LT | N/A |

**Remove & Replace Entire Ramp.**

**R304.5.3, STD 1115**
