# Access Compliance Report Public Rights-of-Way (Curb Ramps)

Main Street: UNIVERSITY\_DR Cross Street: IRVINE\_AVE Location: S

ADA ID: RPRK211018113747 Ramp Type: Type 1 - Perpendicular Diagonal Initial Pass/Fail: Pass Overall Compliance: No Severity Score: 5

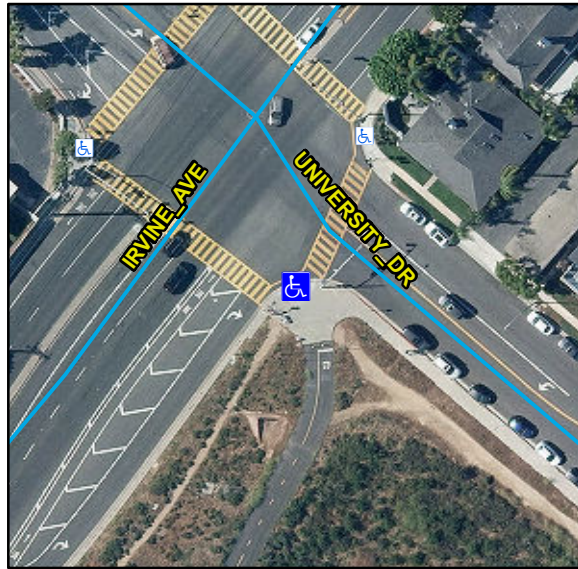
| Compliance | Description | Data | Compliance | Description | Data |
|---|---|---|---|---|---|
| Yes | Gutter Ponding | No | No | Curb Slope | 11.2 |
| No | Gutter Run Slope (%) | 5.9 | | Road Cross Slope (%) | 8.7 |

Remove & Replace Curb Slope. Restripe Crosswalk. Remove & Replace Gutter.
