# Access Compliance Report Public Rights-of-Way (Curb Ramps)

Main Street: IRVINE\_AVE Cross Street: UNIVERSITY\_DR Location: SE

ADA ID: RPRK211018114559 Ramp Type: Type 4 - Parallel Initial Pass/Fail: Fail Overall Compliance: No Severity Score: 15

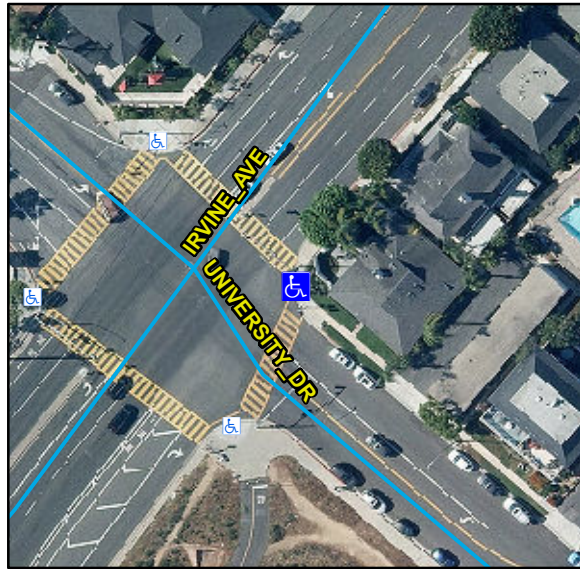
| Compliance | Description | Data | Compliance | Description | Data |
|---|---|---|---|---|---|
| No | Ramp Run Slope LT (%) | 8.5 | Yes | Ramp Run Slope RT (%) | 6.8 |

**Remove & Replace Curb Ramp With Two New Directional Ramps or Equivalent.**

**R304.3.2, STD 1115**

Total Cost: \$ 4000
