# Access Compliance Report Public Rights-of-Way (Curb Ramps)

Main Street: UNIVERSITY\_DR Cross Street: IRVINE\_AVE Location: N

ADA ID: RPRK211018115242 Ramp Type: Type 1 - Perpendicular Diagonal Initial Pass/Fail: Pass Overall Compliance: No Severity Score: 2

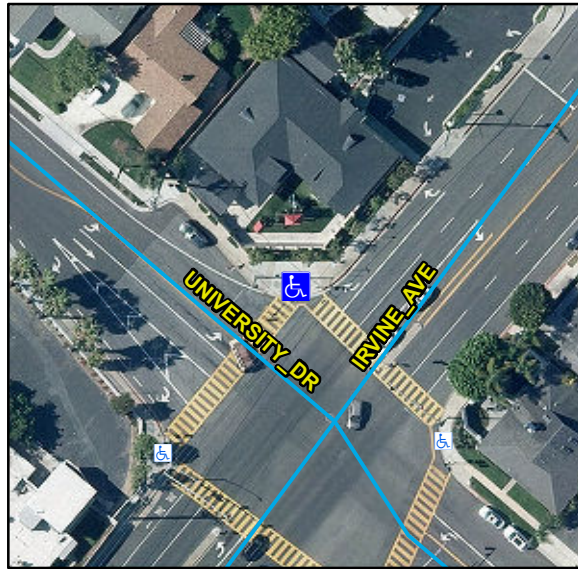
| Compliance | Description | Data | Compliance | Description | Data |
|---|---|---|---|---|---|
| Yes | Gutter Ponding | No | No | Curb Slope | 5.5 |

Remove & Replace Curb Slope.

R304.2.2, STD 1115
