# Access Compliance Report Public Rights-of-Way (Curb Ramps)

Main Street: MIRA\_LOMA\_PL Cross Street: IRVINE\_AVE Location: N

ADA ID: RPRK211018115929 Ramp Type: Type 4 - Parallel Initial Pass/Fail: Pass Overall Compliance: No Severity Score: 0

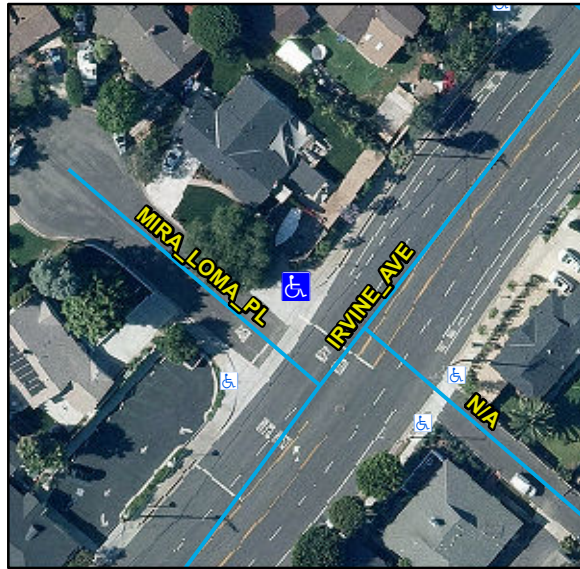
| Compliance | Description | Data | Compliance | Description | Data |
|---|---|---|---|---|---|
| Yes | Gutter Ponding | No | No | Curb Slope | 10.1 |

Remove & Replace Curb Slope.

R304.2.2, STD 1115

Total Cost: \$ 252
