# Access Compliance Report Public Rights-of-Way (Curb Ramps)

Main Street: LA\_CANADA\_WAY Cross Street: IRVINE\_AVE Location: N

ADA ID: RPRK211018120552 Ramp Type: Type 4 - Parallel Initial Pass/Fail: Fail Overall Compliance: No Severity Score: 16

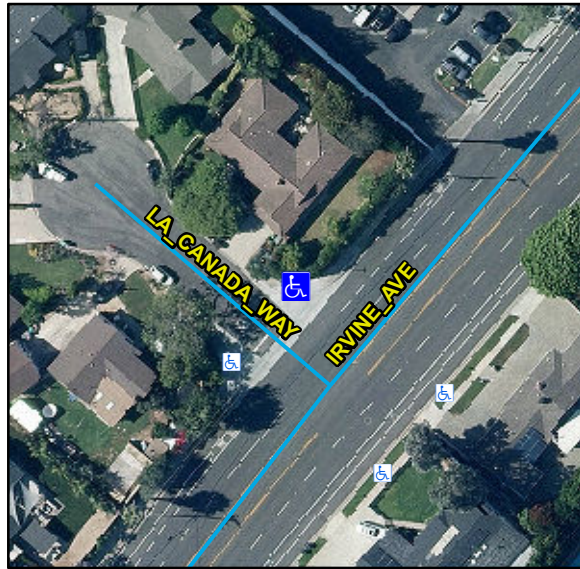
| Compliance | Description | Data | Compliance | Description | Data |
|---|---|---|---|---|---|
| No | Ramp Run Slope LT (%) | 10.2 | Yes | Ramp Run Slope RT (%) | 1.9 |
| No | Ramp Cross Slope LT (%) | 2.2 | Yes | Ramp Cross Slope RT (%) | 1.2 |

Remove & Replace Curb Ramp With Two New Directional Ramps or Equivalent.

R304.3.2, R304.5.3, STD 1115
