# Access Compliance Report Public Rights-of-Way (Curb Ramps)

Main Street: ANNIVERSARY\_LN Cross Street: IRVINE\_AVE Location: S

ADA ID: RPRK211018121817 Ramp Type: Type 1 - Perpendicular Diagonal Initial Pass/Fail: Pass Overall Compliance: No Severity Score: 16

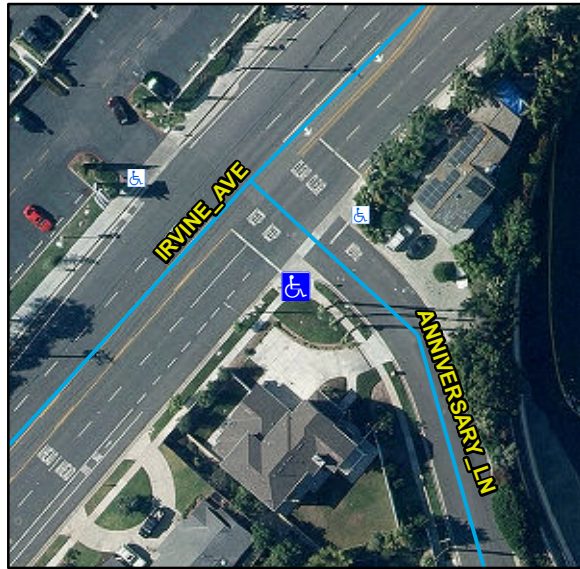
| Compliance | Description | Data | Compliance | Description | Data |
|---|---|---|---|---|---|
| No | Ramp Cross Slope (%) | 2.2 | N/A | Flare Traversable LT | No |
| No | Landing Run Slope (%) | 3 | N/A | Flare Traversable RT | No |
| Yes | Landing Cross Slope (%) | 1.8 | No | DWS Provided | No |
| No | Gutter Cross Slope (%) | 2.5 | | | |

Remove & Replace Curb Ramp With Two New Directional Ramps or Equivalent. Remove & Replace Gutter.
