# Access Compliance Report Public Rights-of-Way (Curb Ramps)

Main Street: N/A Cross Street: IRVINE\_AVE Location: S

ADA ID: RPRK211018123146 Ramp Type: Type 6 - Directional 1 Initial Pass/Fail: Pass Overall Compliance: No Severity Score: 4

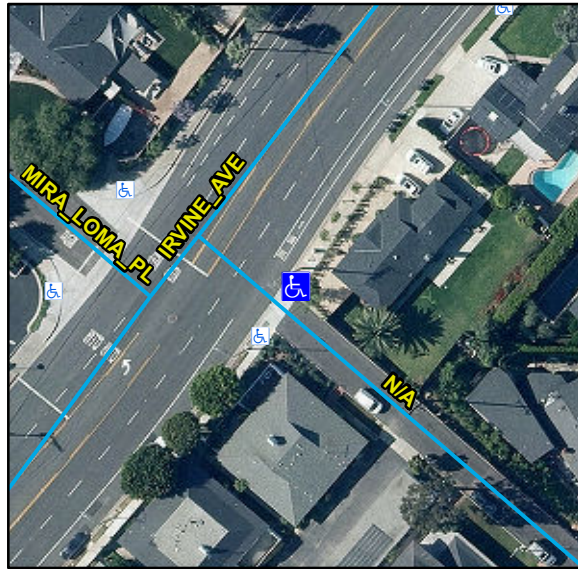
| Compliance | Description | Data | Compliance | Description | Data |
|---|---|---|---|---|---|
| No | Grade Break | No | Yes | Flare Type RT | |
| No | Landing Length (in) | 39 | Yes | DWS Length (in) | 36 |

Remove & Replace Entire Ramp.

R304.2.1, R304.5.2, STD 1115
