# Access Compliance Report Public Rights-of-Way (Curb Ramps)

Main Street: N/A Cross Street: IRVINE\_AVE Location: S

ADA ID: RPRK211018123443 Ramp Type: Type 7 - Directional 2 Initial Pass/Fail: Fail Overall Compliance: No Severity Score: 15

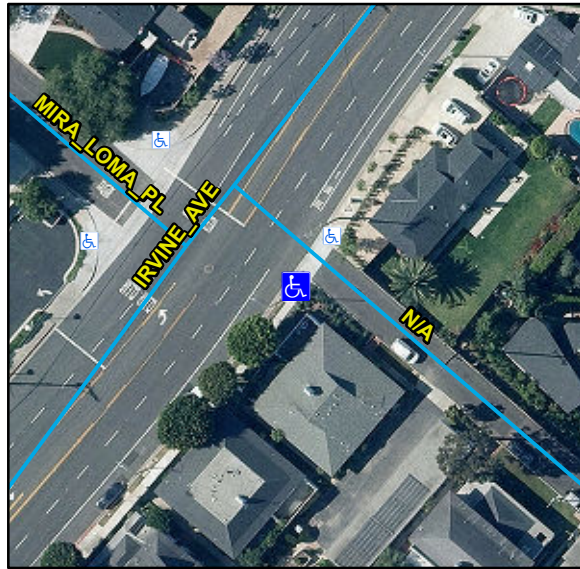
| Compliance | Description | Data | Compliance | Description | Data |
|---|---|---|---|---|---|
| No | Ramp Run Slope (%) | 10.3 | N/A | Flare Slope LT (%) | N/A |

Possible Solutions:

Remove & Replace Entire Ramp.

R304.2.2, STD 1115
