# Access Compliance Report Public Rights-of-Way (Curb Ramps)

Main Street: MONTE\_VISTA\_AVE Cross Street: IRVINE\_AVE Location: N

ADA ID: RPRK211018124450 Ramp Type: Type 4 - Parallel Initial Pass/Fail: Pass Overall Compliance: No Severity Score: 6

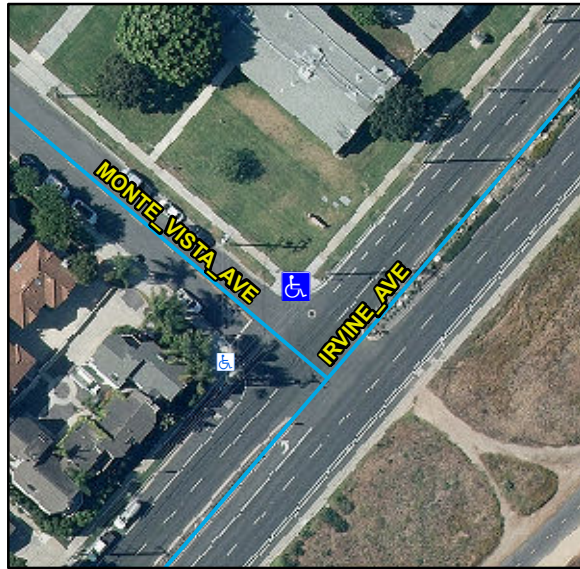
| Compliance | Description | Data | Compliance | Description | Data |
|---|---|---|---|---|---|
| Yes | Gutter Ponding | No | No | Curb Slope | 14.8 |
| No | Gutter Run Slope (%) | 8.4 | | Road Cross Slope (%) | 4.1 |
| Yes | Gutter Cross Slope (%) | 0.5 | No | Perpendicular Joint Present | No |

Remove & Replace Curb Ramp With Two New Directional Ramps or Equivalent. Remove & Replace Gutter.

R304.2.2, R204.3, R304.5.4, STD 1115
