# Access Compliance Report Public Rights-of-Way (Curb Ramps)

Main Street: CASTLETREE Cross Street: WOODSONG Location: S

ADA ID: RPRK211018144711 Ramp Type: Type 1 - Perpendicular Diagonal Initial Pass/Fail: Fail Overall Compliance: No Severity Score: 30

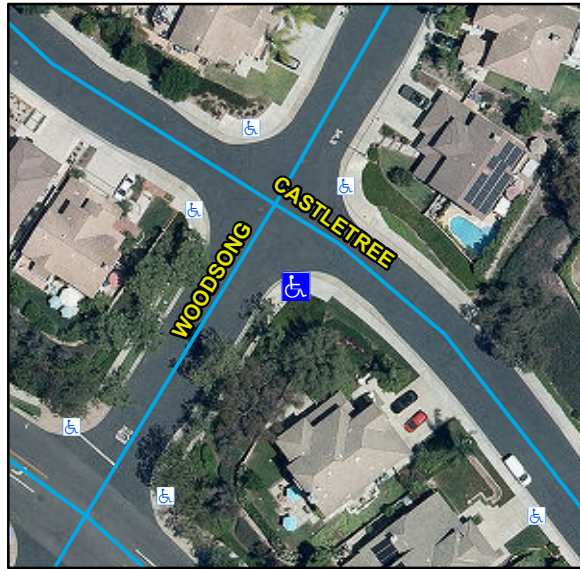
| Compliance | Description | Data | Compliance | Description | Data |
|---|---|---|---|---|---|
| No | Ramp Run Slope (%) | 9.6 | N/A | Flare Slope LT (%) | N/A |
| No | Ramp Cross Slope (%) | 5.3 | N/A | Flare Traversable LT | N/A |
| No | Gutter Lip Height (in) | 0.25 | | Road Run Slope (%) | 4.9 |

**Remove & Replace Curb Ramp With Two New Directional Ramps or Equivalent.**

**R304.2.2, R204.3, R304.5.3, R302.7.2, STD 1115**
