# Access Compliance Report Public Rights-of-Way (Curb Ramps)

Main Street: WOODSONG Cross Street: CASTLETREE Location: E

ADA ID: RPRK211018144930 Ramp Type: Type 1 - Perpendicular Diagonal Initial Pass/Fail: Fail Overall Compliance: No Severity Score: 16

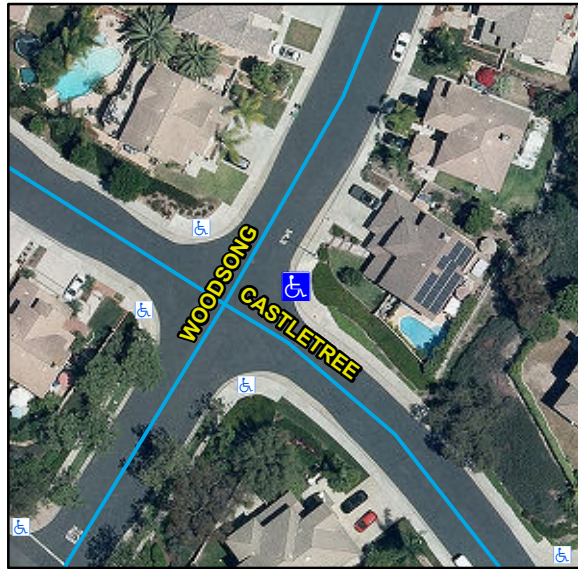
| Compliance | Description | Data | Compliance | Description | Data |
|---|---|---|---|---|---|
| No | Ramp Run Slope (%) | 9.8 | N/A | Flare Slope LT (%) | N/A |
| No | Gutter Lip Height (in) | 0.25 | | Road Run Slope (%) | 1.1 |

**Remove & Replace Curb Ramp With Two New Directional Ramps or Equivalent. Grind Gutter Lip.**

**R204.3, R304.2.2, R302.7.2, STD 1115**
