# Access Compliance Report Public Rights-of-Way (Curb Ramps)

Main Street: CASTLETREE Cross Street: WOODSONG Location: N

ADA ID: RPRK211018145113 Ramp Type: Type 1 - Perpendicular Diagonal Initial Pass/Fail: Fail Overall Compliance: No Severity Score: 15

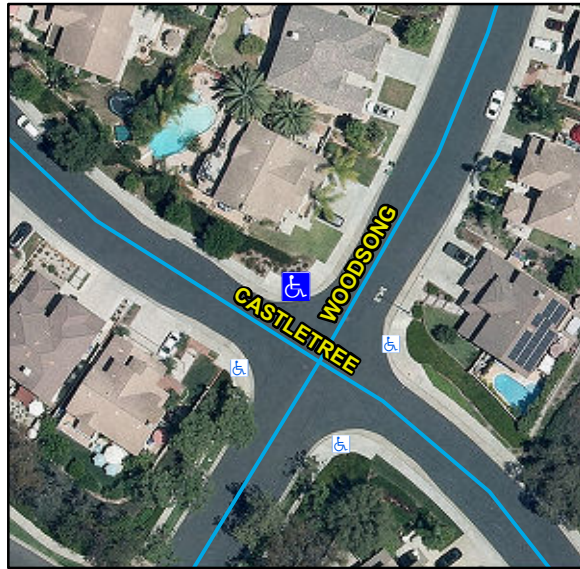
| Compliance | Description | Data | Compliance | Description | Data |
|---|---|---|---|---|---|
| No | Ramp Run Slope (%) | 9.3 | N/A | Flare Slope LT (%) | N/A |
| No | Gutter Lip Height (in) | 0.25 | | Road Run Slope (%) | 2.2 |

**Remove & Replace Curb Ramp With Two New Directional Ramps or Equivalent. Grind Gutter Lip.**

**R204.3, R304.2.2, R302.7.2, STD 1115**
