# Access Compliance Report Public Rights-of-Way (Curb Ramps)

| Main Street: WOODSONG | | Cross Street: CASTLETREE | | Location: | W |
| ADA ID: RPRK211018145314 | Ramp Type:Type 1 - Perpendicular Diagonal Initial Pass/Fail: Fail | | Overall Compliance: No | Severity Score: | 15 |

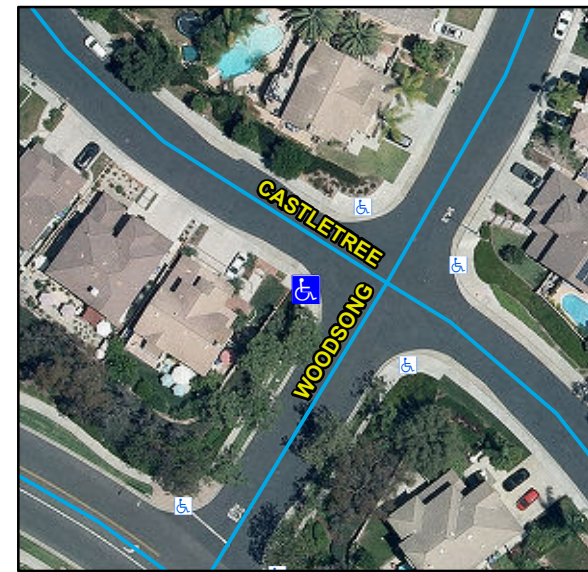
| Compliance | Description | Data | Compliance | Description | Data |
|---|---|---|---|---|---|
| No | Ramp Run Slope (%) | 11.5 | N/A | Flare Slope LT (%) | N/A |
| No | Gutter Lip Height (in) | 0.25 | | Road Run Slope (%) | 3.2 |

**Remove & Replace Curb Ramp With Two New Directional Ramps or Equivalent. Grind Gutter Lip.**
